## EVALUATION OF PILLAR-ROOF INTERFACE AND ITS EFFECT ON PILLAR STABILITY IN RIO DESERTO COAL MINE #101

### ABSTRACT

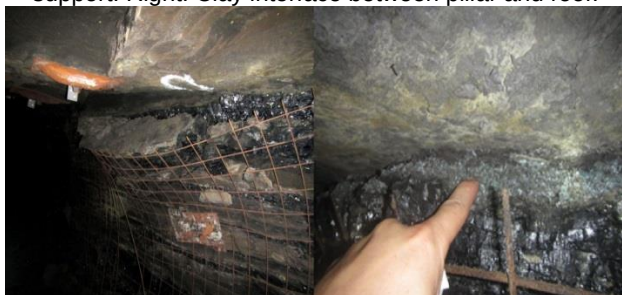
After excavation of a new panel, pillars started to develop damages such as cracks and fractures. The damages developed on the upper half of the pillar with a clear focus in the corner between the pillar and roof. A majority of the damages was found on the down-slope side of the pillar. However, some damages were also observed on the up-slope side. Damage inspections by the mine also found a thin clay layer located between the pillar and the overlying siltstone (Figure 1). The layer is soft and the thickness between 20-40mm. It is believed that the clay interface is affecting the pillar strength and caused the damages.

Figure 1 Left: Pillar damages and steel mesh used for support. Right: Clay interface between pillar and roof.

It might also be possible to support and reinforce the pillars to prevent damages. A common supporting method for coal mines located in the USA is to combine right-angle-irons, steel mesh and bolts. The right-angle-irons provide support to both the wall as well as the roof. Meanwhile, the steel mesh retains rocks and it can undergo large deformations which might be induced by the shear movement (Figure 6).

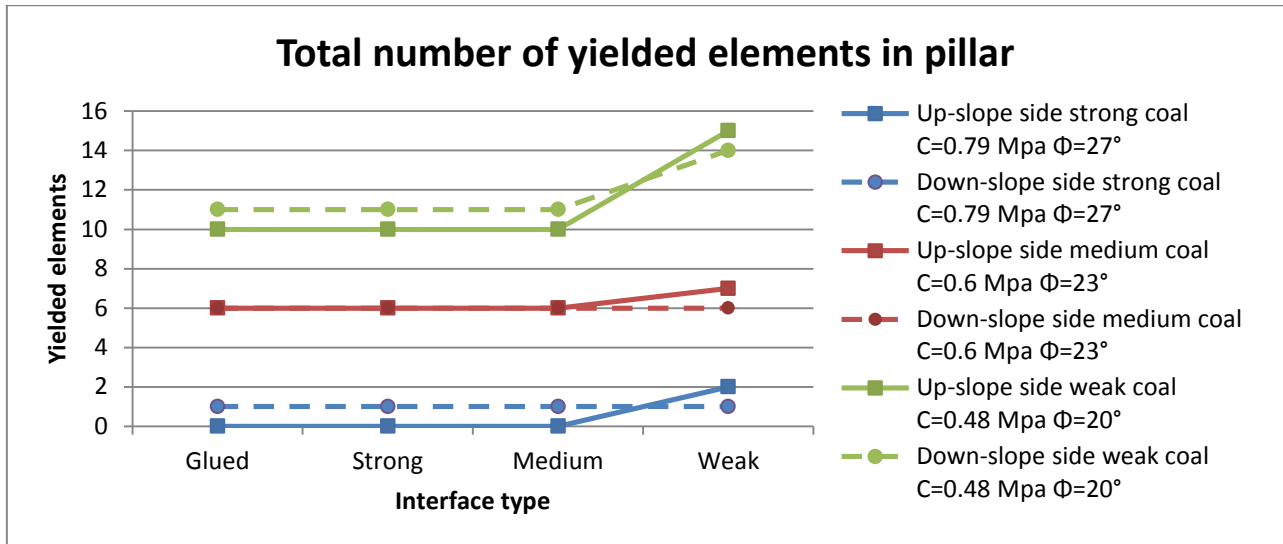
The first scenario modelled, with a varying coal and clay strengths, results in a larger amount of pillar damages (yielded elements) for a weak coal

strength compared to a strong coal. There is little or no difference between the amounts of damages on the up- and down-slope side of the pillar. It is also observed how the amount of damages is constant

for a glued, strong and medium strength interface. The amount of damages in the pillar only increases when the clay interface strength is significantly reduced (Figure 4).

Figure 4 - Comparison between the number of yielded elements developed on each side of the pillar for different coal strengths.

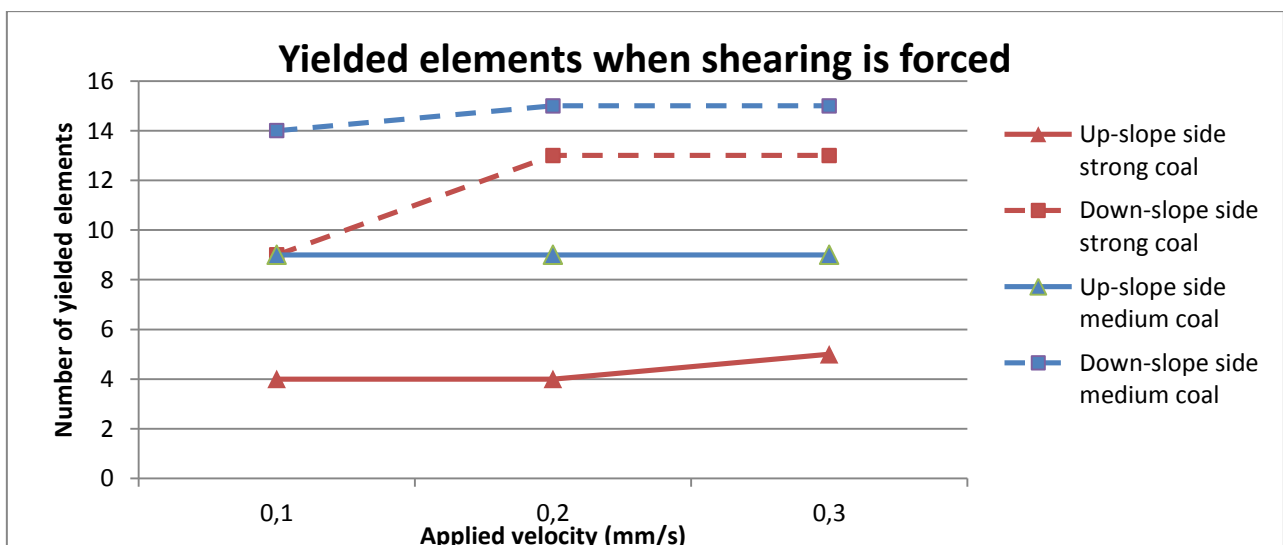
In the final scenario the result show that an increased shear movement (8-25 mm) along the interface reproduce a damage pattern much similar to the field observations. The results indicate an increase of 225% when comparing damages on the down- and up-slope side of the pillar (Figure 5).

Figure 5 - Yielded elements with different applied velocities.

The results indicate that the damages observed in field are best reproduced when increasing shearing along the interface up to 8-25 mm. Hence, shearing along the clay interface is believed to be the source mechanism behind the observed pillar damages. Other major conclusions and findings in this project can be summarized as:
