## PREDICTIVE MAINTENANCE USING THERMOGRAPHY TECHNIQUES FOR INSPECTION OF PIPES

**Herminio Pertel Netto**  
**Victor Dadalto Cuzzuol**  
**Pedro Rosseto de Faria**  
**Lucas Antônio Silveira Silva**  
**André Luiz Perazzo Amaral**

College UCL – ES 010 Highway, km 6 – Manguinhos – Serra/ES

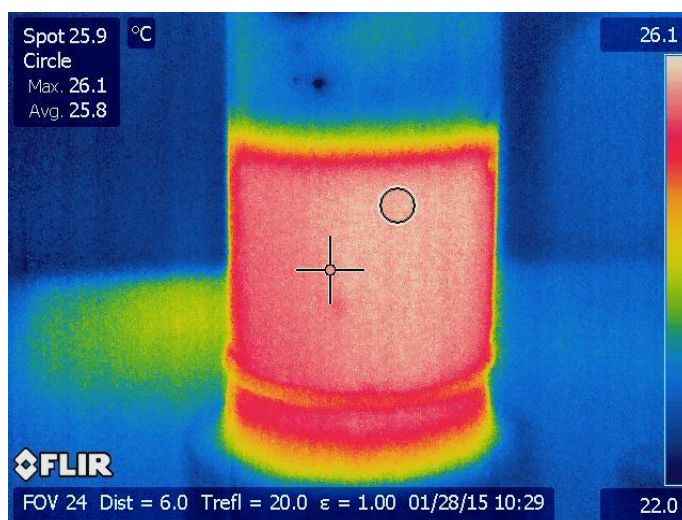
To confirm the efficiency of the use of this inspection, it was executed this technique in a pipe where the wear was already known. The test was first carried out in a new section of pipe and its thermal image (Fig. 1) shows a uniform temperature profile. Two more tests were conducted in the same section of the pipe: (i) one after a little sanding in the pipe, as shown in Fig. 2 a) – white zone in the middle of the section, and (ii) other after a severe sanding in a point where there was almost a leak, as shown in Fig. 2 b) – white point in the lower zone.

Figure 1. New pipe with water

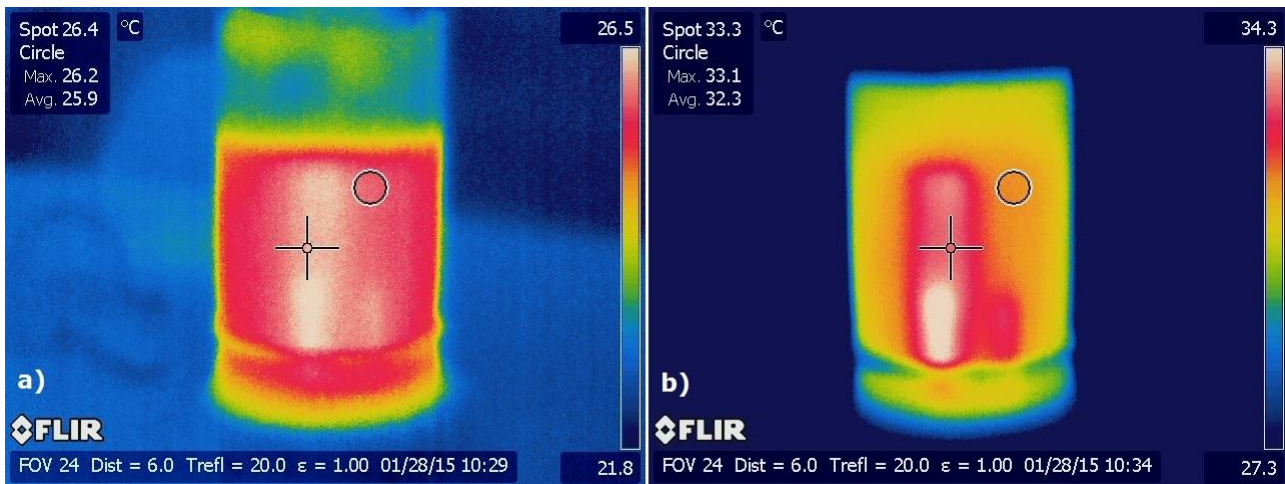
Figure 2. Pipe with water: a) little worn and b) almost leaked by wear

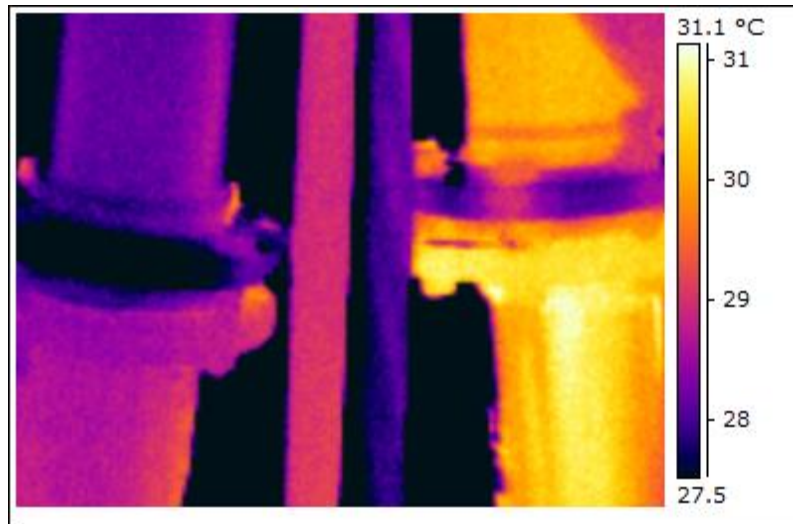
Figure 4 shows the generated thermal image that allows identify that the pipe (right side) is carrying coal slurry at the time of image capture, due to higher temperature compared to the disabled pipe (left side).

Figure 4. Thermal pipe image

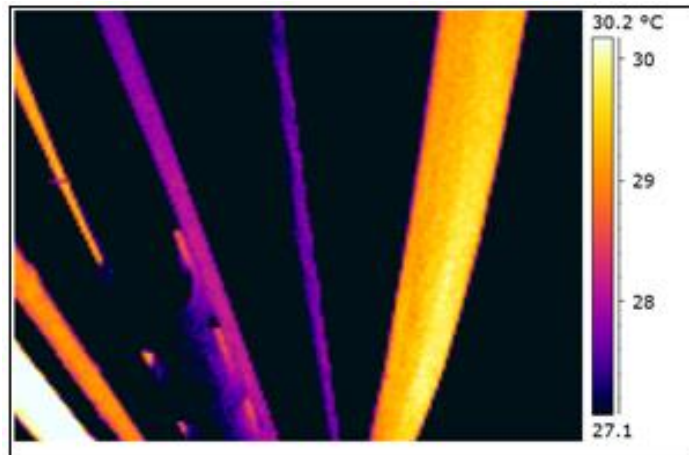
The reflection, showed in Fig. 6, is a problem that can change the diagnosis given to any equipment as it can portray something unreal in the thermal image. Some precautions can avoid this problem, like not capture the image directly in front of the target to avoid reflect yourself, move from side to side to see if the point in the image also moves, and detect thermal gradients in the image, because the reflexes generally do not exhibit the same (ITC, 2008).

Figure 6. Radiation interference in the thermal image

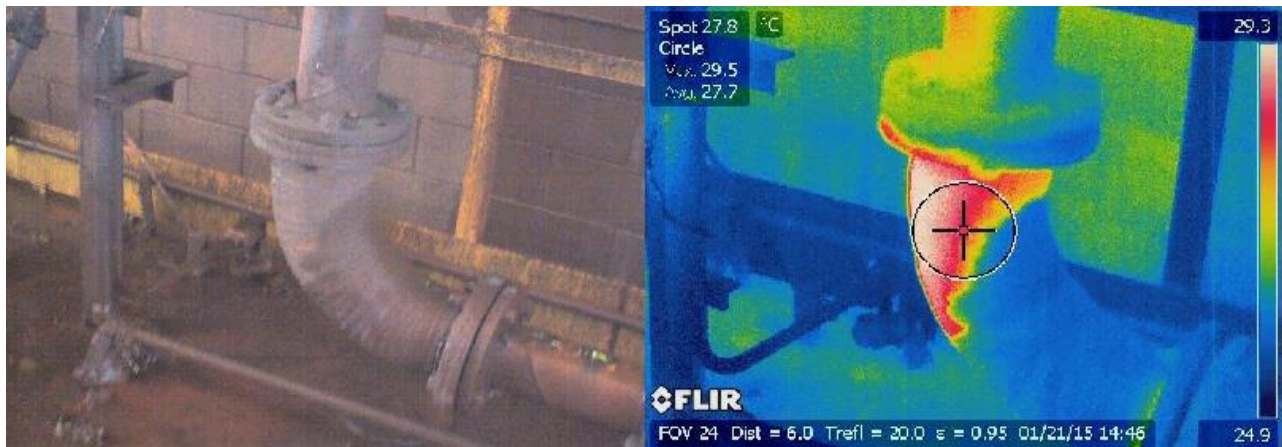
Another case that can mask the result of thermographic test is the effect of external factors on the system under study, such as leaking oil, water, or any other unusual substance to the environment studied. In Fig. 7, it is possible to observe the unexpected effect that can cause a leak in a thermographic inspection.

In the studied section, the inspectors did not realize the leakage and made the capture of the image. The result scared everyone, due to a huge temperature variation in a region where it was not expected some wear because the area was affected by an external factor. There was a leak in the junction between the straight section and the pipe bend, which wet the outer wall and change, significantly, the thermal image.

Figure 7. Interference of a leak in the thermal image

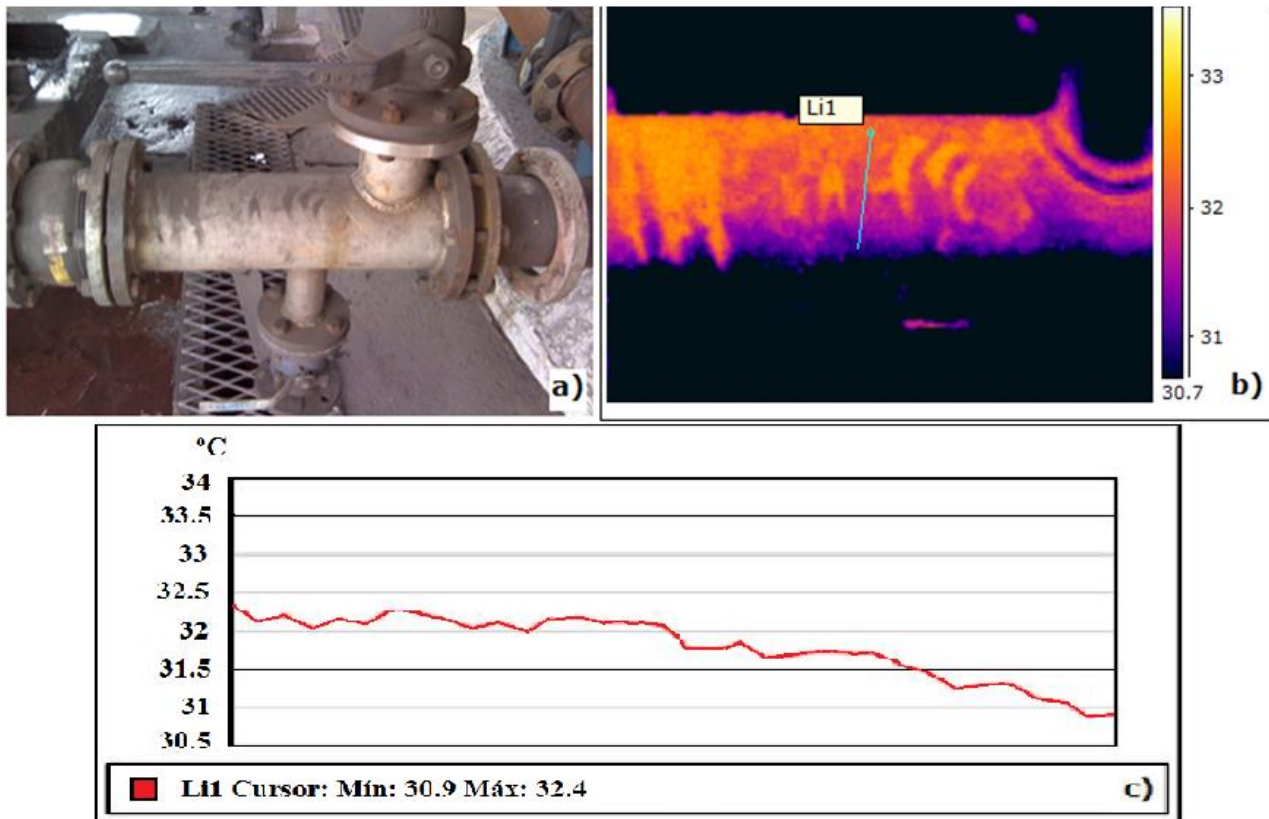
Another external factor that can change the diagnosis in a thermographic inspection is the dust that is impregnated in the outer wall of the pipe, as can be seen in Fig. 8a).

The thermal image generated, Fig. 8b), is a result of an inspection where an unexpected temperature variation was identified in a straight section of the duct. When the inspectors analyzed the pipe, they identified the existence of a lot of dust on the surface of it.

The graph showed in Fig. 8c) helps to see the magnitude of the temperature variation and shows what a simple dust is able to generate at the thermal image. The variation founded was 2.5°C in the studied section.

Figure 8. Dust interference: a) in real plant, b) thermal image and c) temperature variation at line 1 (Li 1)

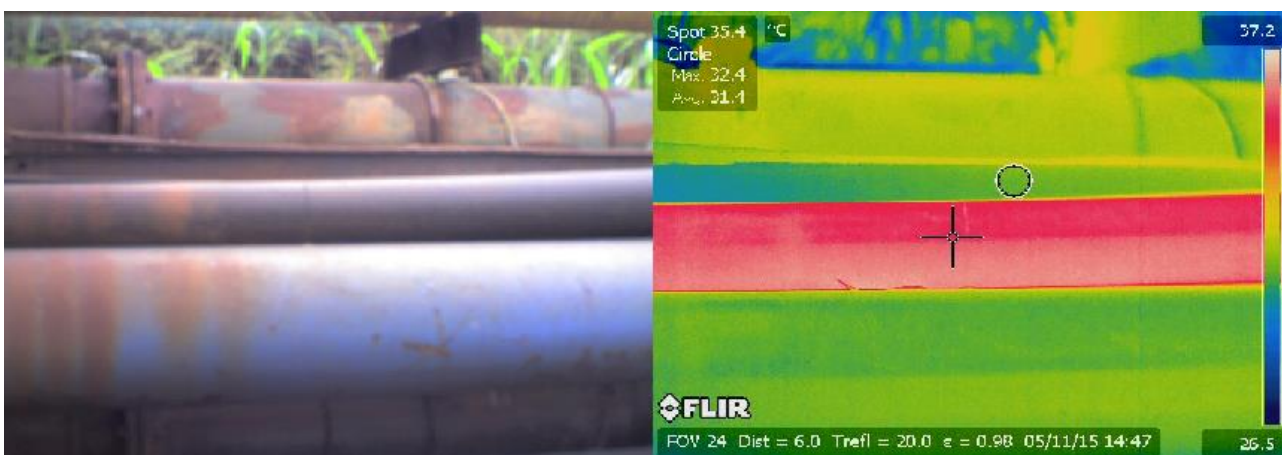
Images captured at the stage of the Thermographic inspection procedure tests shows the pipes carriers coal slurry of Vale S.A. and their respective thermal images. In Fig. 9 and 10 there are points where the temperature is higher than the expected, which implies that the thickness of the pipe wall is smaller, and actions must be taken to avoid the unexpected disruption of the pipe.

The cause of this wear is due to the friction generated by the contact of coal slurry with the inner wall of the pipe, which generates the heat perceived by the Thermographic camera.

Figure 9. Pipe carrier coal slurry and your corresponding thermal image

In Fig. 9, there is a straight section of pipe carrier coal slurry where the inspectors suspected wear and decided to hold a Thermographic inspection to see if the suspect was true. Equipped with a FLIR P640 camera, the inspector captured a thermal image of the pipe under study and identified a temperature variation in the bottom of the pipe, which occurs due to wear in the inner wall of the duct.

This wear occurred in the lower region, due to the action of gravity on the coal, pressing it against the lower region of the duct. The thermal image shows this variation of temperature.

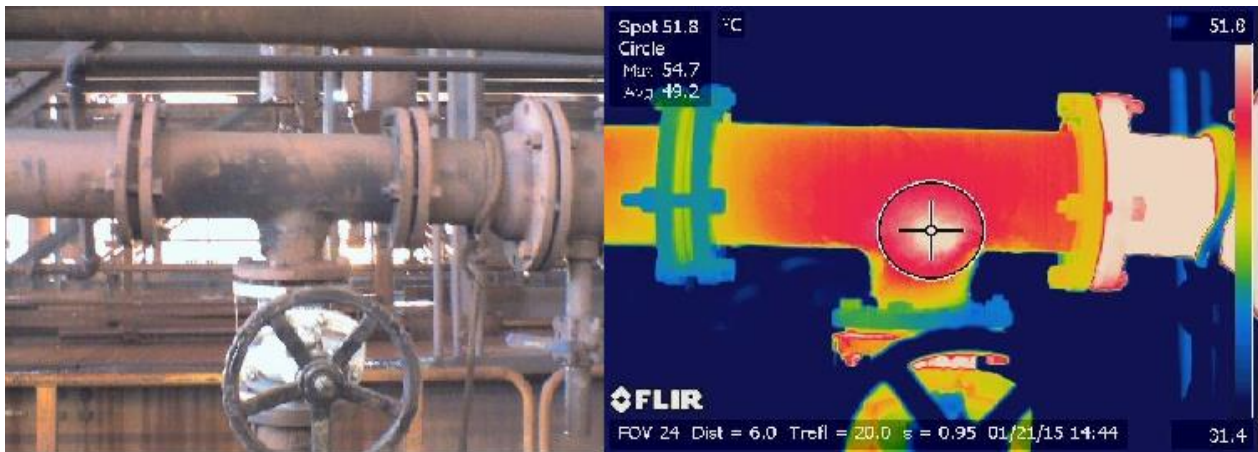
Figure 10 shows that there is wear on the inner lining of the duct and a considerable variation in temperature in the center of the intersection "T", which proves the existence of the wear, generated by the friction of this coal slurry with the pipe wall.

Figure 10. Articulation in the pipe carrier coal slurry and your corresponding thermal image

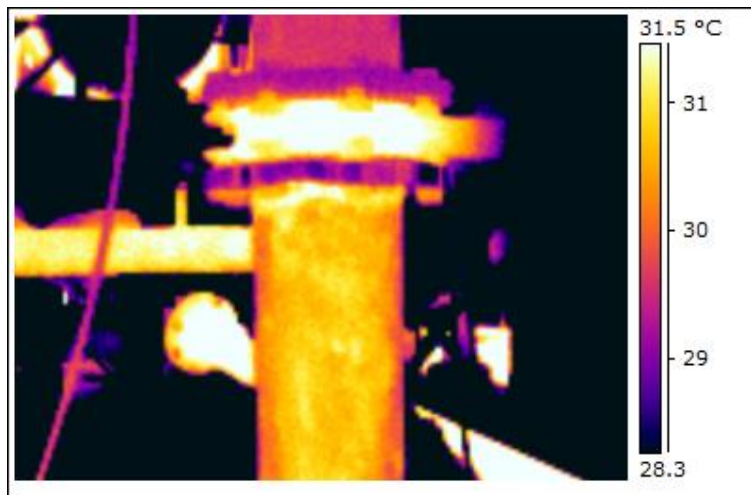
In the example showed in Fig. 11, temperature variations has been identified in the region of the junction between two ducts, which as in previous examples, representing a wear in the connection studied.

Figure 11. Thermal image of the pipe junction
