# STRESS ANALYSIS OF A FAILED STAINLESS STEEL FEMORAL PLATE

**Abstract.** Surgical implants are exposed to severe working conditions and therefore a wide range of failure mechanisms may occur, including fatigue, corrosion, wear, fretting and combinations of them. An 83-year-old patient suffered an oblique femoral shaft fracture due to a fall at home. The plate fractured along one of the combination holes, approximately aligned to the femur fracture and with no screw locked into it. A FEM model of the orthopaedic implant was developed in order to estimate the stress distribution along the femoral plate. The numerical simulation was done with a computer code developed by one of the authors. The adopted finite element is the isoparametric solid tetrahedron of quadratic order. Two models have been numerically analyzed: one with four screws, and one with three screws (that is, with an empty hole on the femoral plate). The distribution of the von Mises stress was obtained at the end of the simulation. The numerical results show that the removal of one of the screws leads to a stress increase around the empty hole. The maximum value of the von Mises stress for the model with an empty hol

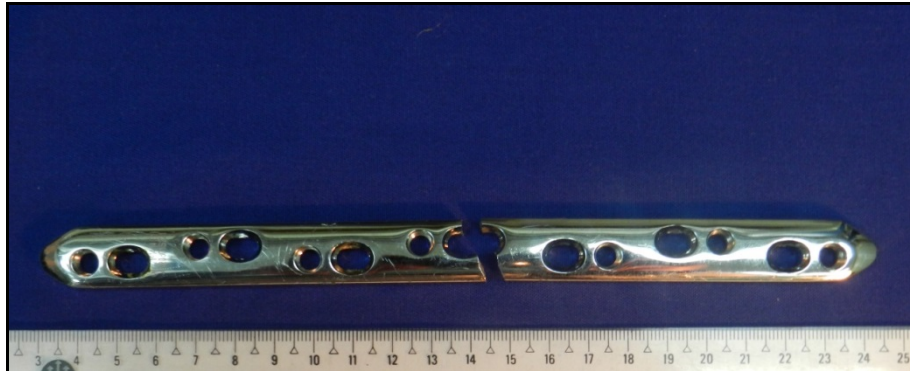
In the present work, a failed femoral plate is considered. An 83-year-old patient suffered an oblique femoral shaft fracture due to a fall at home. A locking compression plate (LCP) employed in the fracture reduction failed after four months and was sent back to the producer. A second LCP of the same type was implanted and also failed after six months. Both implants were manufactured by the same supplier. A failure analysis of the second femoral LCP was performed in a previous paper (Marcomini *et al.*, 2014). A FEM model of the orthopaedic implant was developed in order to estimate the stress distribution along the femoral plate and is presented in this paper. There was no presence of rusts or corrosion on the failed plate surface, which presented a typical stainless steel brightness. The plate fractured along one of the combination holes, see Fig. 1, approximately aligned to the femur fracture and with no screw locked

into it. The fractured surfaces were analyzed in order to investigate the macro and microscopic fracture features. Two fracture origins could be found. Probably, both crack fronts nucleated almost at the same time in stress concentration sites. Beach marks observed close to the fracture origins revealed that the fracture mechanism was fatigue.

Figure 1. The fractured femoral plate

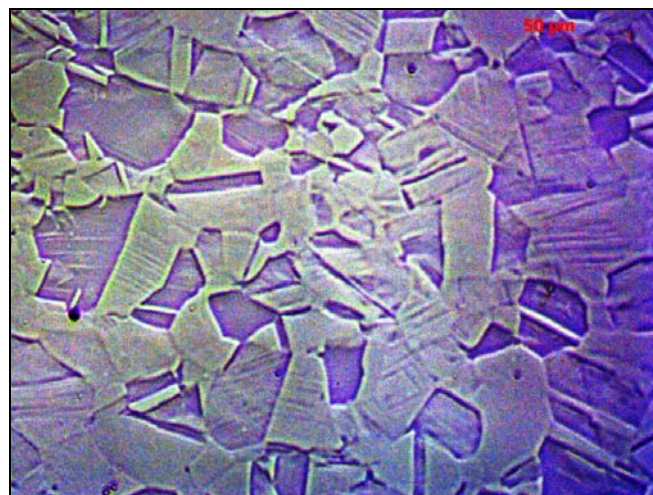
An optical microscope metallographic analysis was performed in order to investigate the microstructure, grain size and sensitization degree. Samples were taken from a parallel position of the femoral plate longitudinal axes. The metallographic analysis revealed that the austenitic grain size of the steel is between 6 and 7 according to ASTM E 112. The microstructure shown in Figure 2 reveals many slip lines and annealing twins, which shows that the material was subjected to cold work. The specimens etched with oxalic acid at 1 A/cm<sup>2</sup> for 1.5 min revealed a sensitization pattern similar to “End Grain Pitting I” according to ASTM A 262. Figure 3 shows the optical microscope images of stainless steel sensitized microstructure.

Figure 2. Optical microscope image of the microstructure of the femoral plate stainless steel without etching

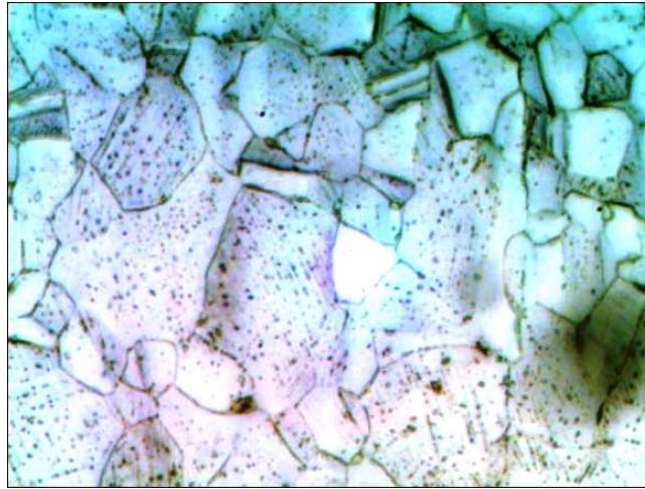
Figure 3. Optical microscope image of the sensitized microstructure of the femoral plate stainless steel after electrolytic etching (oxalic acid at  $1 \text{ A/cm}^2$  for 1.5 min) showing carbide precipitation ( $\text{Cr}_{23}\text{C}_6$ )-sensitization

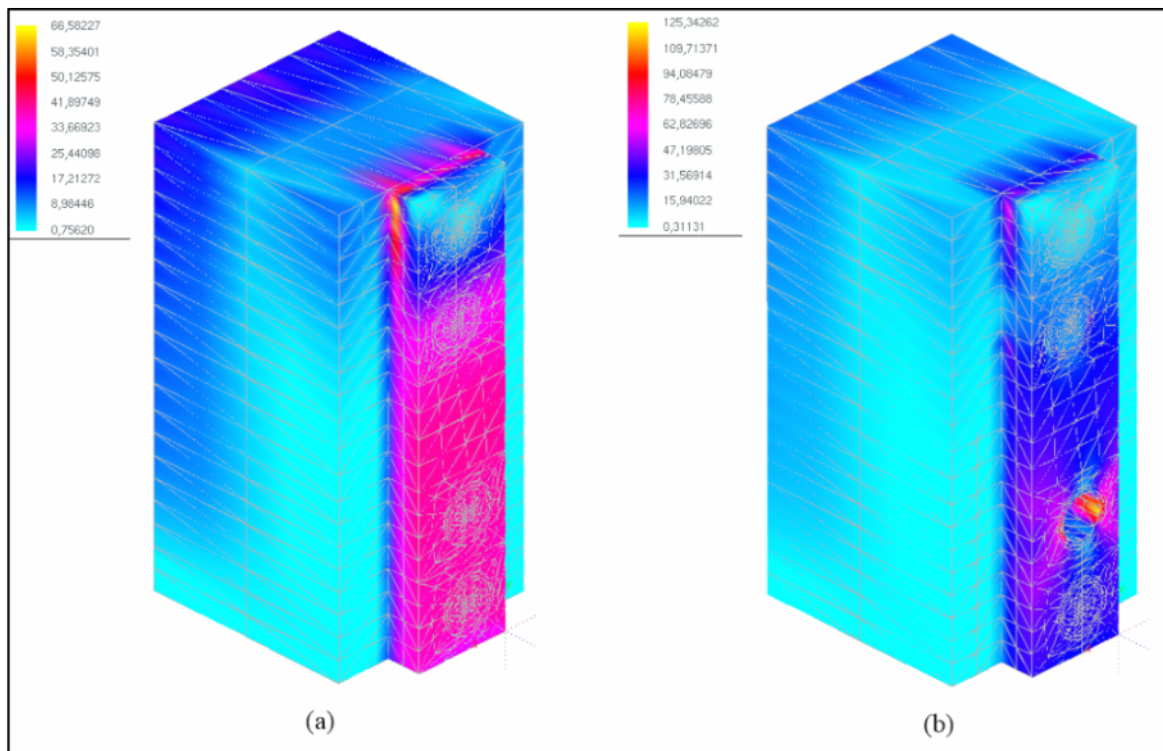
Two models have been numerically analyzed: one with four screws and one with three screws (that is, with an empty hole on the femoral plate). For the first case, the mesh employed has 18785 nodes and 12096 tetrahedral elements. The mesh of the second model has 18077 nodes and 11520 tetrahedra. The distribution of the von Mises stress is obtained at the end of the simulation. The numerical results show that the removal of one of the screws leads to a stress increase around the empty hole, see Fig. 5. The maximum value of the von Mises stress for the model with an empty hole is 125.3 MPa and occurs around the hole. For the model with four screws, the von Mises stress at the same

point is 39.8 MPa. Thus, the stress concentration factor, considering the present model, is 3.15. It should be verified if this stress level is acceptable from the point of view of fatigue. The fatigue endurance limit of austenitic steels under bending could be estimated as  $0.37 S_u \approx 361$  MPa for the steel used in the femoral plate (Lee *et al.*, 2005). Upon the stress raiser, whereas the austenitic stainless steels in the annealed condition is not notch sensitive, it was observed in the fatigue curves of a cold-drawn 304 stainless steel that the cold-worked condition has much lower fatigue strength if samples are notched, with the fatigue strength decreasing from 760 to about 170 MPa (Brooks, 1992). On the other hand, even if the steel used in the femoral plate is fully-notch sensitive ( $q = 1$ ), the fatigue stress concentration factor would be not enough to induce crack initiation under usual loading. However, it must be stated that, because of notch sensitivity, the use of cold-worked material may not provide an advantage over annealed material with regard to fatigue strength (Brooks, 1992).

Figure 5. Final von Mises stresses: (a) four screws; (b) three screws with an empty hole

From the stress analysis, it can be inferred that the femoral LCP presents no design problem and the absence of one screw at the analyzed hole is not a critical stress concentration point. The surface finish of the device suggests the complete absence of corrosion influence on the fracture process.
