## **ANALYSIS OF THE CAUSE OF THE FRACTURE OF THE PISTON ROD OF THE SPILLWAY FLOODGATE OF TUCURUÍ HYDROELECTRIC POWER PLANT**

**Abstract:** *This paper presents a technical investigation that analyzes the cause of the fracture in some movement piston rods of the spillway floodgates of Tucuruí hydroelectric power plant. This investigation was divided into two parts: experimental and theoretical. Structural elements were monitored in a real service situation, with forces measured by strain gages. The results obtained in the experimental test were used in numerical solutions based on the Finite Element Method to check stress concentrations present in the notch of the piston rod, performing a fatigue analysis by the  $\epsilon$ -N method of crack initiation and analyzing different semi-elliptical cracks to identify the approximate size that causes the rupture of the piston rod.*

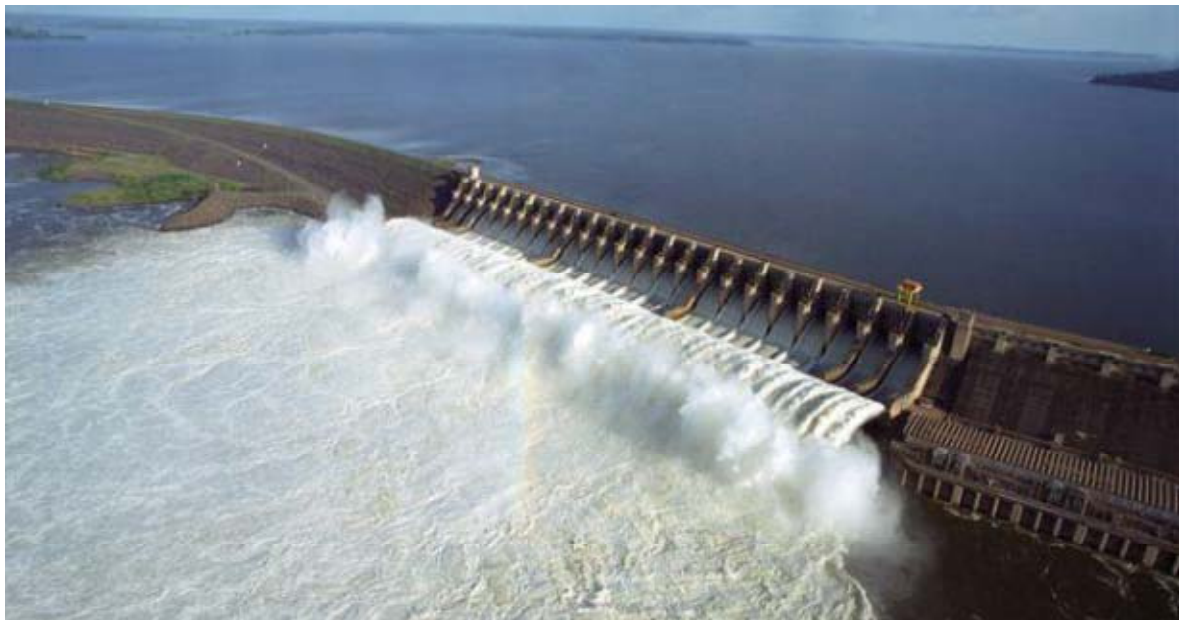
Tucuruí Hydroelectric power plant (HPP Tucuruí) has one of the biggest spillways in the world with a total capacity of  $110,000 \text{ m}^3/\text{s}$ , as shown in Fig. 1. The main function of the spillway is to release all the exceeding water, not used for energy generation, keeping the reservoir level within the normal operation range, and preserving the stability of the slopes of the reservoir banks. The spillway of Tucuruí is built to face an exceptional flood with an occurrence probability of 1/1000 years. During the 35 years of Tucuruí dam existence, the greatest flow rate registered in the spillway was  $68,400 \text{ m}^3/\text{s}$ , which is about 62% of the maximum capacity. Tucuruí's spillway has 23 floodgates, with individual flow capacity of  $4,780 \text{ m}^3/\text{s}$ . Two hydraulic cylinders enable to open and close a floodgate. The piston rods and cylinders were designed to work during the whole dam life. However, cracks and ruptures have begun to appear in several piston rods.

**Figure 1. Spillway of HPP Tucuruí**

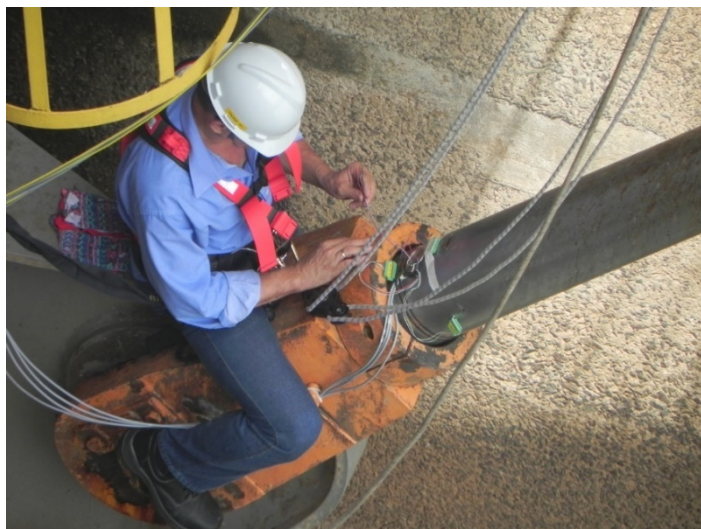
Choosing where to install the strain gages, as shown in Fig. 3, was based on Saint-Venant principle, which states that: "... stresses that may be produced in a body by applying, in a small part of its surface, a system of loads which is statically equivalent to zero, have inconsiderable magnitude in longer distances than the linear dimensions of the body."

Due to lack of access to the notch of the piston rod, as observed in Fig. 3, and to the fact that stresses close to it are not uniform, the established criterion was installing strain gages at a distance greater than the diameter of the piston rod, starting from the notch. The uniformity of stresses where strain gages were installed, as well as the stresses at the notch of the piston rod where cracks occur, were part of the numerical investigation.

**Figure 3. Strain Gages Installation**

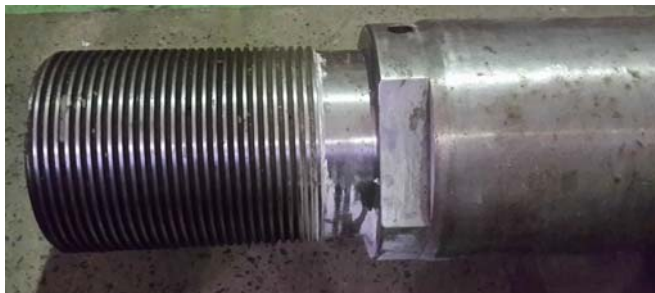
The software was used to develop a geometrically correct finite element model, three-dimensional, representing the threaded end of the piston rod presented in Fig. 8. The constructive design is shown in Fig. 9 and the element mesh of the 3D object generated by the software is shown in Fig. 10.

**Figure 8. Threaded End of the Piston Rod**
