## IMPROVEMENTS TO SLIDING BEARINGS OF THE PROPELLER SHAFTS OF THE MOTORS FOR SHIPS USED ON INLAND WATERWAYS

**Abstract.** *The continuous operation of the propeller shaft of a ship in water with high pH and many dispersed particles cause excessive wear on the sliding bearings that support the shaft. This wear causes a clearance of up to 6 mm in radius on the shaft. The problem is the wear of the polymer coating of bronze bushings, which in contact with the circular shaft and sleeve due to stress, produce premature wear of the joint. This creates serious problems in the operation of the transmission of the ship. This problem is very specific to this type of inland waterways in the Amazon region. Therefore it is necessary to find a solution that can be generalized to other boats operating in this environment. At work several ways to approach and troubleshoot the problem to prevent premature wear on the joints of ship propulsion are discussed.*

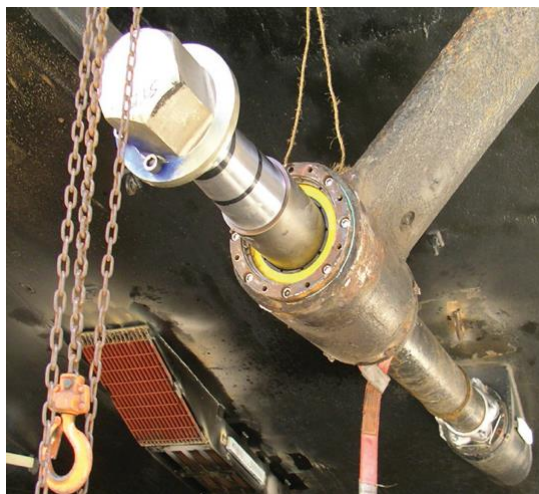
The propeller water-cooled shaft works with slide bearings, where the joint is composed of a bronze sleeve, high wear resistance, placed at the point of support with a bronze bushing coated internally with Thordon SXL, type of polymer used to guarantee high wear resistance and capable of support the loads that are acting, while also ensuring proper alignment of the shaft (Cowper, et al., 2006; Ren and Muschta, 2011; Ken and Craig, 2010; Thordon Newsworks, 2006; Thordon Bearings Inc., 2014). “Fig. 2” and “Fig. 3”.

Figure 2. Supports of the propeller shaft

- Internal part composed of a bronze sleeve lining the propeller shaft at all points of support. See “Fig. 2”
- Outside consists of a bronze bushing inside covered by the polymer Thordon SXL (Thordon Newsworks, 2006; Thordon Bearings Inc., 2014). See “Fig. 4”

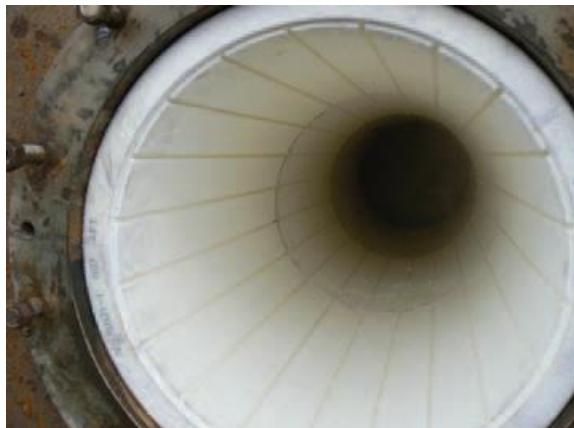
Figure 4. Bushing coated with Thordon SXL

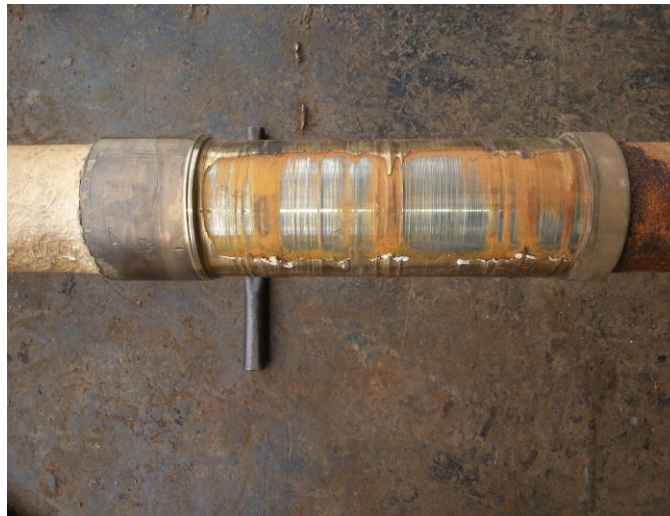
Approximately seven months after installation of the propulsion system in the boat, he began to show excessive clearance in the bearings. It was realized a visual inspection detecting a possible displacement of the protective sleeve on the shaft (Latorre and Dünow, 1981).

Later, it was verified that the bronze sleeve had not moved. When removing bronze sleeve the presence of excessive wear was verified, reaching the allowed limit that almost affecting the shaft surface. See “Fig. 5”

Figure 5. Bronze sleeve wear

After making a detailed study of the problem, together with specialists from several companies, and verify that the polymer Thordon SXL has a high resistance to wear in working conditions was studied and considered that it was necessary replace the bronze sleeve lining the shaft, for their problems to work in an environment where abrasive wear dominates, by a material with better performance, was proposed replacement of bronze sleeve by a sleeve of carbon steel Chromium Nickel Boron coating with a minimum thickness of 0.5 mm and a surface hardness of 55 to 60 HRC.

Propeller shaft sleeve was manufactured using steel 1045 with a cementation treatment with quenching tempering, to obtain a surface hardness of 55 HRC, mounted in the position of the corresponding supports.

1. Modify the material of the protective shaft sleeve for carbon steel coated Nickel Chrome Boron and a minimum thickness of 0.5 mm, or other coating with hardness 55-60 HRC.

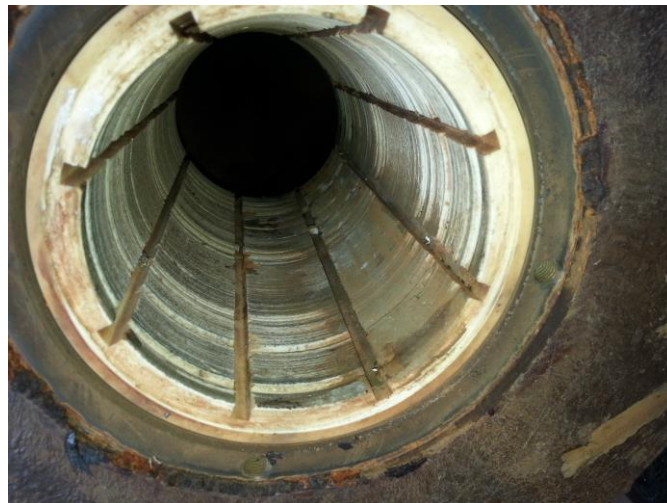
The inner lining of the bushings with polymeric material Thordon SXL (Thordon Newsworks, 2006; Thordon Bearings Inc., 2014), was not worn, but it was damaged by the incrustation of bronze particles due to intensive process of bronze sleeve wear that protects the shaft. See “Fig. 6”.

Figure 6. Polymer lining damage

The bushing covered with the polymer Thordon SXL suffered no wear, but was damaged by incrustation of bronze particles due to heavy wear of bronze sleeve.

The bushing covered with Thordon SXL had bronze pieces embedded in its inner diameter.

Due to the high water pollution in the region was requested to the firm Thordon Bearings Inc., that the thickness of the slots in the bushings should be increased up to 10 mm, to facilitate the movement of water and decrease sedimentation and with this the abrasive effect.

3. Due to the high abrasiveness of the waters of the Amazon region, it is recommended to the firm Thordon Bearings Inc, that the thickness of the slots in the bushings should be increased up to 10 mm.
