## STUDY OF THE VIABILITY OF DEFECTS EVALUATION IN TBC COATINGS BY EDDY CURRENT NON DESTRUCTIVE TESTING

*Thermal barrier coatings (TBC) are widely used in components subject to oxidizing atmospheres and high temperature operations. Such components normally showed a two layer coating, a metallic coating against oxidation and a ceramic coating with intend to reduce the temperature of the component. In this work the samples were manufactured with one layer composed by a NiCrAlY bond coat and a second layer composed of a ceramic Ytria Stabilized Zirconia are deposited on an Inconel 718 substrate. In this case the eddy current method, with intend to examine these coatings has been used. This paper presents the study of the viability of this application in coating system with some defects. These defects were prepared with intention to simulate some defects like: cooling holes, substrate failure and ceramic coating failure. This study, with eddy current non-destructive testing, indicated that it is possible the evaluation of the coatings with the presence of defects and cooling holes.*

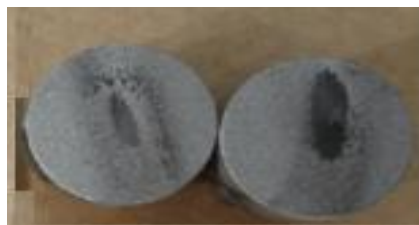
To simulate the occurrence of detachment between the bond coat and top coat, samples were prepared with HVOF coating and these bond coats were grinded to reduce the roughness and reduce the ceramic coating adhesion, Fig. 4.

Figure 4- Samples with bond coat sanded.

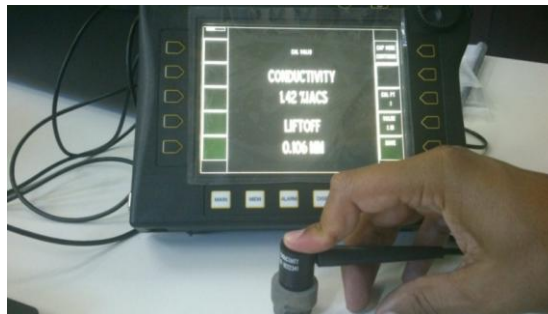
When performing analysis of the sample with bond coat deposited on Inconel 718, with the conductivity probe 480KHZ, Fig. 8, it was found that the probe was reading the bond coat thickness, 106  $\mu\text{m}$  in these samples. It was observed that these measurements are in accordance with the optical microscopy analysis.

Figure 8 - Conductivity and thickness (lift-off) reading in the sample with bond coat deposited on Inconel 718.

The metallic coating measurement was possible due to changes on the electrical conductivity between the bond coat and the superalloy substrate. The results are confirmed by the impedance plan changes, shown in Fig. 7(b), which shows the conductivity of the sample deposited slightly smaller than the superalloy substrate.

In order to analyze the bond coat influence on the base metal with eddy current test, it can be concluded that the eddy current method can measure the thickness of the bond coat, because of the metallic bond coating layer have different electrical conductivity, compared with the Inconel 718 base metal.
