## RISK ANALYSIS OF THERMOSYPHON ASSISTED DRYING AIR HEATING SYSTEM

**Keywords:** Risk analysis, two-phase thermosyphon, air heating system.

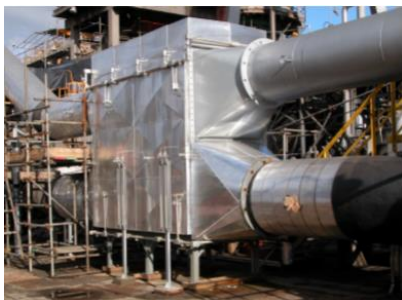
Figura 5. Thermosyphon heat exchanger.

exchanger with similar characteristics to the one showed in Fig. 5. It is important to detach this technology was successfully used in Xisto refinery (SIX) in São Mateus do Sul, Paraná. Drying air heating system with new configuration can be divided into three subsystems: firewood feed system, furnace system and thermosyphon heat exchanger system as showed in Fig. 6.

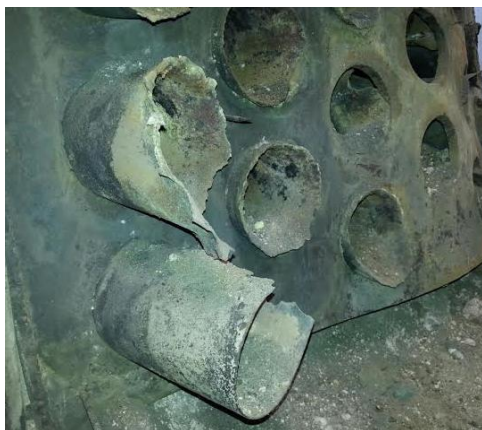
Figura 13. Generated failure by thermal radiation on heat exchanger tubes.

Analyzing FMECA can be identified explosion failure as more critical in the system with severity of 10 and makes sense to carry out FTA analysis which is presented in section 3.3. Another critical item is combustion chamber, as showed “*in situ*” study of current drying air heating system used at Baldo S.A. Figure 13 presents equipment generated damage by thermal radiation on first tubes of shell and tube heat exchanger. It was observed that generated damage on heat exchanger tubes caused gas combustion leakage in temperatures greater than 700 [°C], generating high impact on security and functionality loss for a long period of time until normal restoration.
