# Adhesion evaluation between asphalt and geosynthetic layers using microscopy technics

**SUMMARY:** Geosynthetics have been commonly used as asphalt reinforcement during new pavement construction or overlay in order to form an anti-reflective cracking interlayer. Asphalt coat is usually applied at the interface to ensure proper bond between layers, being tack coat type (e.g. RR-1C) and application rate critical parameters to guarantee an acceptable adhesion between layers. Scanning electron microscopy was the technique used to analyze adhesion between asphalt and geosynthetic layers. Asphalt samples reinforced with geosynthetic and previously submitted to bending test were analyzed by scanning electron microscopy with the purpose of a better understanding of bending and shear effects. This work aims to define the most appropriate way to prepare samples of a highly heterogeneous material, reinforced asphalt concrete. The images obtained via SEM showed that geosynthetic fibers are not always perfectly covered with asphalt binder. Moreover, the reinforcement layer has porosity that can difficult the traffic load distribution, which may be an indication of decreased shear strength in

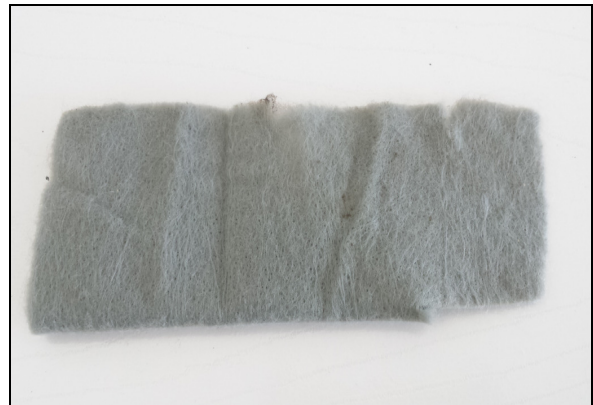
Figure 1: Type of Geotextile used to reinforce asphalt concrete specimens.

Fonseca (2015) has shaped a total of fifteen specimens of asphalt concrete beams, (45 cm x 15 cm x 10 cm) in order to be tested over tensile strength in bending: five specimens had geotextile as reinforcement (Figure 1), five had geogrid as reinforcement (Figure 2) and, the other five specimens had no reinforcement.

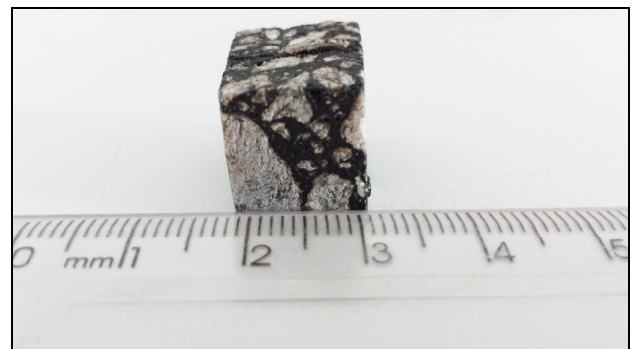
Figure 5: Asphalt concrete test sample with dimensions close to one centimeter.

The asphalt concrete specimens were first cut to remove slices approximately 5 cm thick, as shown in Figure 4. After that, the asphalt concrete slices were cut to sample size suitable for microscopy analysis, with dimensions close to 1 cm, similar to the test sample that can be seen in Figure 5.

Sample sectioning was done by diamond cutting wheel and water was utilized for lubrication and cooling the cutting process. Polishing is not indicated for this type of material because asphalt binder may melt during polishing process. After sectioning, samples were submitted to carbon coating and

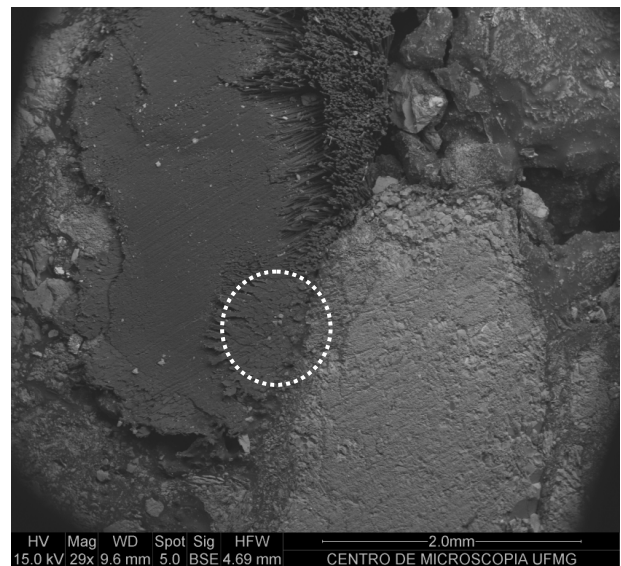
Figure 8: SEM image of sample 4i (30x zoom)

Sample number 4, which has geogrid reinforcement, is the first sample to be analyzed. Figures 7 and 8 display, respectively, images with an increase of 30 times of sample 4e (taken from the area located under the support of the asphalt concrete beam) and 4i (taken from the area near the site of specimen breaking). There was apparently a detachment in sample 4e (Figure 7), because there is a gap among the geogrid fiber and the asphalt layer shown by the white arrows.

Sample 4i (Figure 8) appears to be attached more uniformly to the layer of asphalt and its aggregates, especially in the area indicated by the white circle.

The areas demarked in Figures 7 and 8 were then expanded to show more details of the geosynthetic-asphalt layer interface. Figures 9 and 10 are showing an increase of 150 times of samples 4e and 4i, respectively. It is clear that geogrid fibers shown in sample 4e are not adhered to the asphalt layer while it is possible to see in Figure 10 that fibers are well bonded to an asphalt matrix aggregate.
