# Rockfall Hazard Rating System Adaptation Proposal for Urban Areas Through a Case Study in Mariana (MG, Brazil)

**SUMMARY:** The uncontrolled growth of urban areas causes the occupation of geotechnical hazard zones. This work addresses the geotechnical characterization of a large and steep rock slope in a recently inhabited zone in the Cabanas neighborhood, municipality of Mariana. The slope is composed of a quartzite in the Itacolomi Group and exhibits unstable blocks. The downstream area is occupied, suffering a considerable rockfall risk. For a rockfall hazard evaluation, the Rockfall Hazard Rating System (RHRS) was applied, which was originally conceived for roadway slopes, in order to select those sectors with remediation priority. Therefore, the original method has been adapted in this work for urban slopes. For this reason, some of the parameters used in the original method were modified and adapted to the new situation. Other parameters were not considered, due to their non-applicability. This work applies the Rock Mass Rating System (RMR), instead of the original geological feature parameter, to represent the mechanical behavior of the rock mass and addresses a detailed

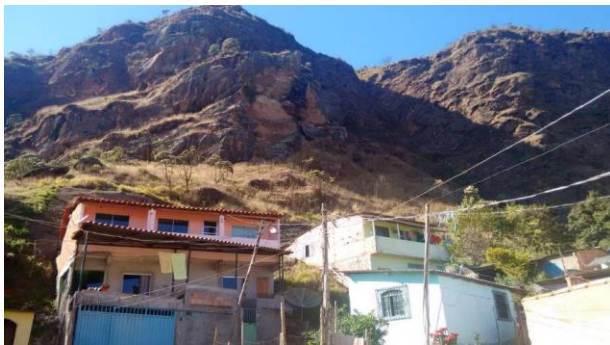
Figure 2. Slope in the Cabanas district.

The slope located in the Cabanas district is composed of quartzite of Itacolomi Group. The rock mass is extremely fractured, as shown in Figure 2. The mineralogical composition revealed quartz, sericite, biotite and muscovite.

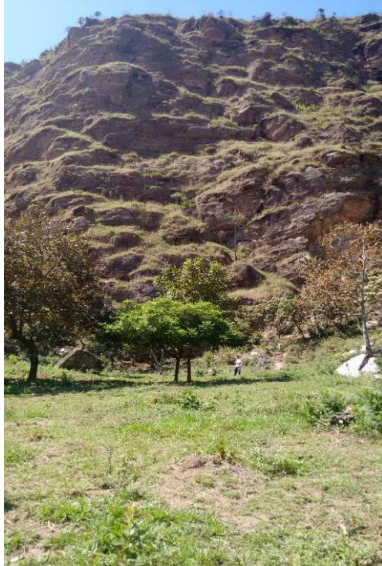
Figure 3. Sector 2D.

The geometry of the catchment area and the vegetation are very important in rockfall hazard analysis, because they may be determining for a rock block to reach or not a building. For example, great lengths and low inclination angles represent safer conditions. Vegetation can reduce the kinetic energy of the block, because it behaves like a shock absorber. Figure 3 shows the sector 2D, with the highest height slope and no relevant vegetation, but with a large catchment area.

It was expected that due to the S2D catchment area characteristics, low inclination angle and great extent, the value of rockfall index would have been low, when compared to the others, but its slope height and the lower quality of the rock mass (compared to others) meant that the final value was relatively high.
