## EVALUATION OF PILLAR-ROOF INTERFACE AND ITS EFFECT ON PILLAR STABILITY IN RIO DESERTO COAL MINE #101

### ABSTRACT

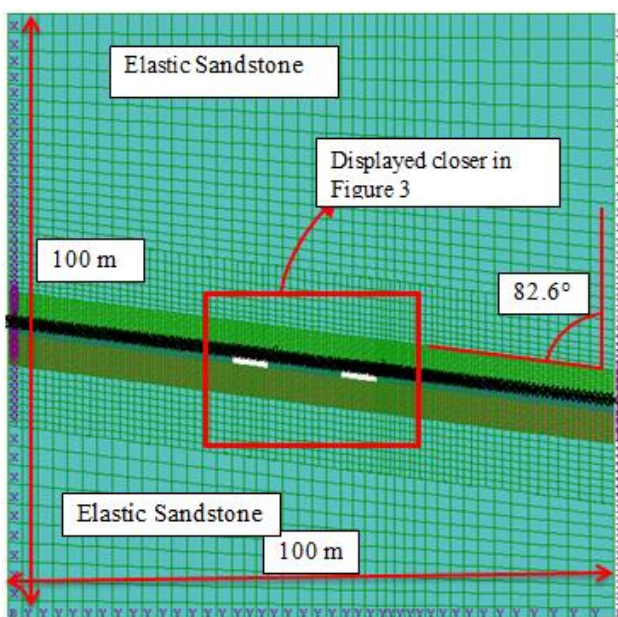
Figure 2 - Left: Overview of the entire model. Right: Close-up view over pillar.

meters. The pillar is surrounded by two drifts, each with a width of 6 meters. An interface is created between the coal seam and the overlying siltstone to represent the thin clay layer. The interface allows for sliding movements between the two materials. However, it does not allow for separation, rotation or dislocation of the materials. The zoning conditions are set to medium for the entire model. In areas within, above or beneath the coal seam is the zoning densified two and four times. The material properties applied to the model are those evaluated by UFRGS, mainly through uniaxial and triaxial testing. In addition, text book and assumed values and also used. Gravitational stresses are applied to the model which can be seen in Figure 2 and 3.
