# STRESS ANALYSIS OF A FAILED STAINLESS STEEL FEMORAL PLATE

**Abstract.** Surgical implants are exposed to severe working conditions and therefore a wide range of failure mechanisms may occur, including fatigue, corrosion, wear, fretting and combinations of them. An 83-year-old patient suffered an oblique femoral shaft fracture due to a fall at home. The plate fractured along one of the combination holes, approximately aligned to the femur fracture and with no screw locked into it. A FEM model of the orthopaedic implant was developed in order to estimate the stress distribution along the femoral plate. The numerical simulation was done with a computer code developed by one of the authors. The adopted finite element is the isoparametric solid tetrahedron of quadratic order. Two models have been numerically analyzed: one with four screws, and one with three screws (that is, with an empty hole on the femoral plate). The distribution of the von Mises stress was obtained at the end of the simulation. The numerical results show that the removal of one of the screws leads to a stress increase around the empty hole. The maximum value of the von Mises stress for the model with an empty hol

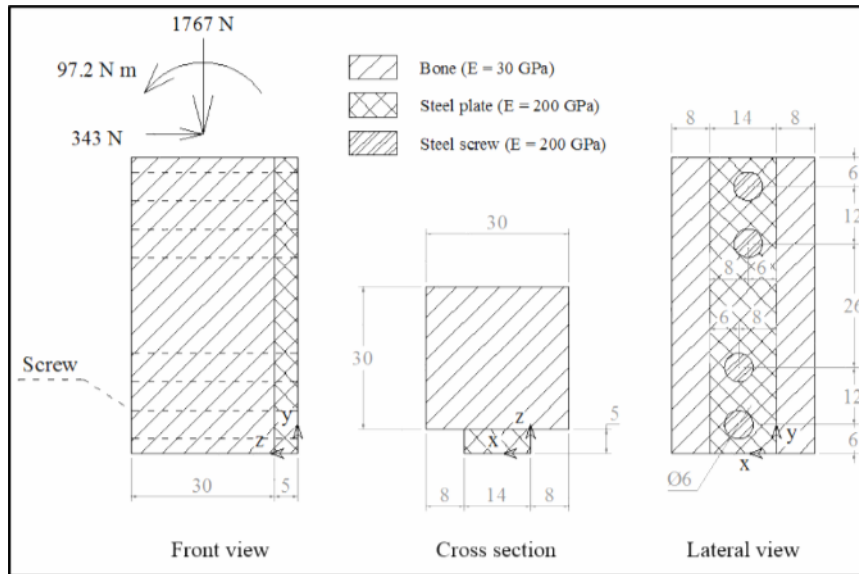
The numerical model generated, depicted in Fig. 4, is based on the experimental procedure used in Kanchanomai *et al.* (2008), in which the applied load is oblique and eccentric regarding the femur. In the present simplified model, the bone and the femoral plate are prismatic bars. The bone has a square cross-section, and the femoral plate model has a rectangular cross-section with four holes along the length. As the femoral plate holes are aligned in pairs, two groups of two aligned holes each has been adopted. Regarding the constitutive modeling, the mechanical behavior is governed by the three-dimensional Hooke's law. The applied static force has a magnitude of three times the patient's weight of 60kg (which means 1800 N), which is equivalent to following loading system: normal compressive force of 1767 N, shear force of 343 N, and a bending moment of 97.2 N m (see Fig. 4). To reproduce the boundary conditions of the test presented in Kanchanomai *et al.* (2008), the base of the bone ( $y = 0$ ) is clamped, i.e., all the displacements of the points located at the base are restricted. Finally, to simplify the analysis, the interaction among the bone, the screws and the femoral plate is considered rigid.

Two models have been numerically analyzed: one with four screws and one with three screws (that is, with an empty hole on the femoral plate). For the first case, the mesh employed has 18785 nodes and 12096 tetrahedral elements. The mesh of the second model has 18077 nodes and 11520 tetrahedra. The distribution of the von Mises stress is obtained at the end of the simulation. The numerical results show that the removal of one of the screws leads to a stress increase around the empty hole, see Fig. 5. The maximum value of the von Mises stress for the model with an empty hole is 125.3 MPa and occurs around the hole. For the model with four screws, the von Mises stress at the same

point is 39.8 MPa. Thus, the stress concentration factor, considering the present model, is 3.15. It should be verified if this stress level is acceptable from the point of view of fatigue. The fatigue endurance limit of austenitic steels under bending could be estimated as  $0.37 S_u \approx 361$  MPa for the steel used in the femoral plate (Lee *et al.*, 2005). Upon the stress raiser, whereas the austenitic stainless steels in the annealed condition is not notch sensitive, it was observed in the fatigue curves of a cold-drawn 304 stainless steel that the cold-worked condition has much lower fatigue strength if samples are notched, with the fatigue strength decreasing from 760 to about 170 MPa (Brooks, 1992). On the other hand, even if the steel used in the femoral plate is fully-notch sensitive ( $q = 1$ ), the fatigue stress concentration factor would be not enough to induce crack initiation under usual loading. However, it must be stated that, because of notch sensitivity, the use of cold-worked material may not provide an advantage over annealed material with regard to fatigue strength (Brooks, 1992).

Figure 4. Numerical model generated for the stress analysis of the femoral plate (dimensions in millimeters)

From the stress analysis, it can be inferred that the femoral LCP presents no design problem and the absence of one screw at the analyzed hole is not a critical stress concentration point. The surface finish of the device suggests the complete absence of corrosion influence on the fracture process.
